Coastal erosion field trip at the Sea Grant's Mid-Atlantic Regional Meeting with North Carolina Sea Grant Specialist Spencer Rogers

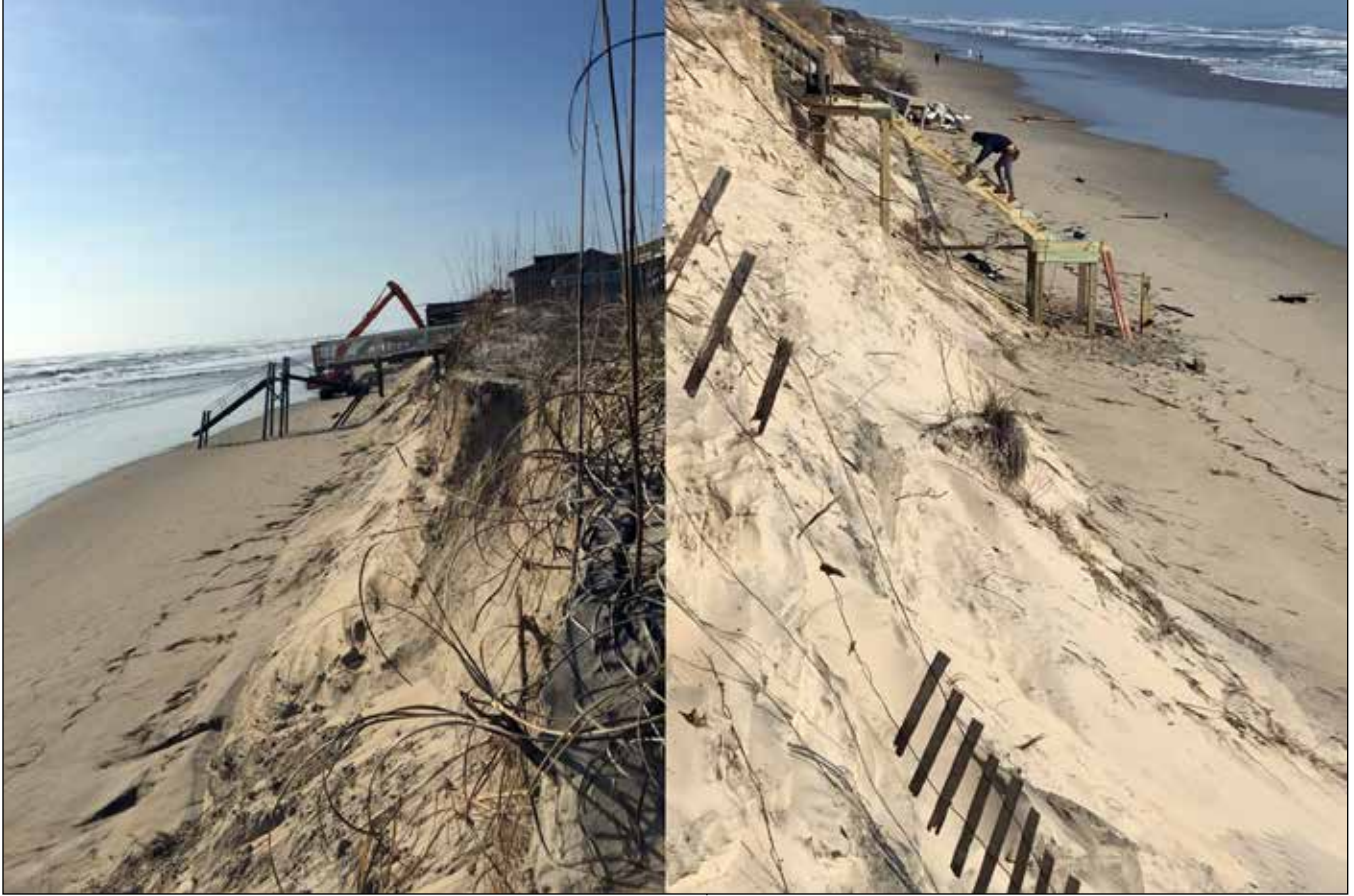
a site in Currituck County just south of the Currituck National Wildlife Refuge. Rogers had been contacted by a property owner to take a look at the damage the last nor'easter caused to the walkway and dunes (Figure 2). Besides the walkway having a major scarp, the steps to the beach were destroyed and the dune was drastically eroded. Just to the south, the group witnessed a bulldozer destroying a dune while trying to modify the slope of the scarp; most likely hired by a local homeowner unaware of regulations and lacking a big-picture perspective on coastal resiliency.

Figure 2 (above). Erosion of dunes and damaged walkovers on private property in Currituck County.

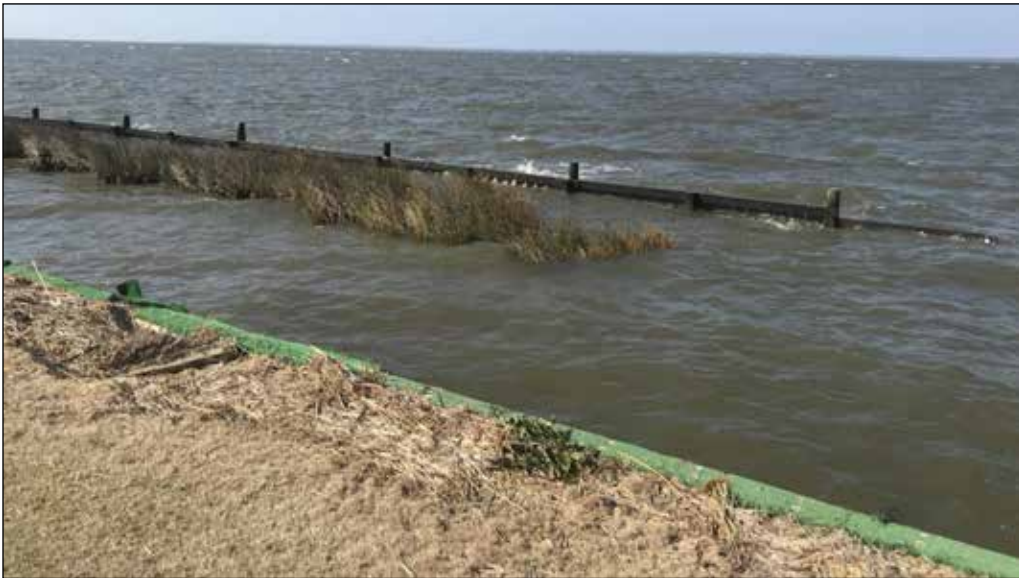
six-inch wood boards with ½- to 1-inch gaps between them (Figure 3). This design facilitated wave attenuation while allowing living organisms and water to pass through to the shore. The area was planted with cordgrass (genus *Spartina*) and juncus (genus *Juncus*) for habitat and stabilization, however only the juncus succeeded.

Figure 3 (left). Living shoreline of fencing and plants on bay side.

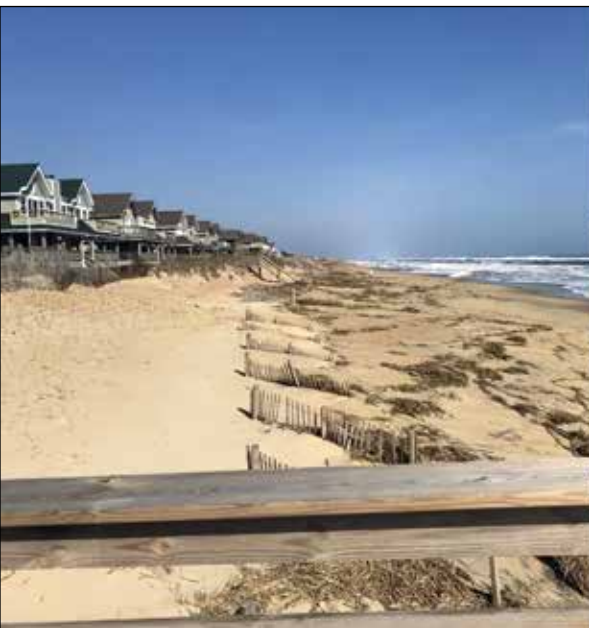
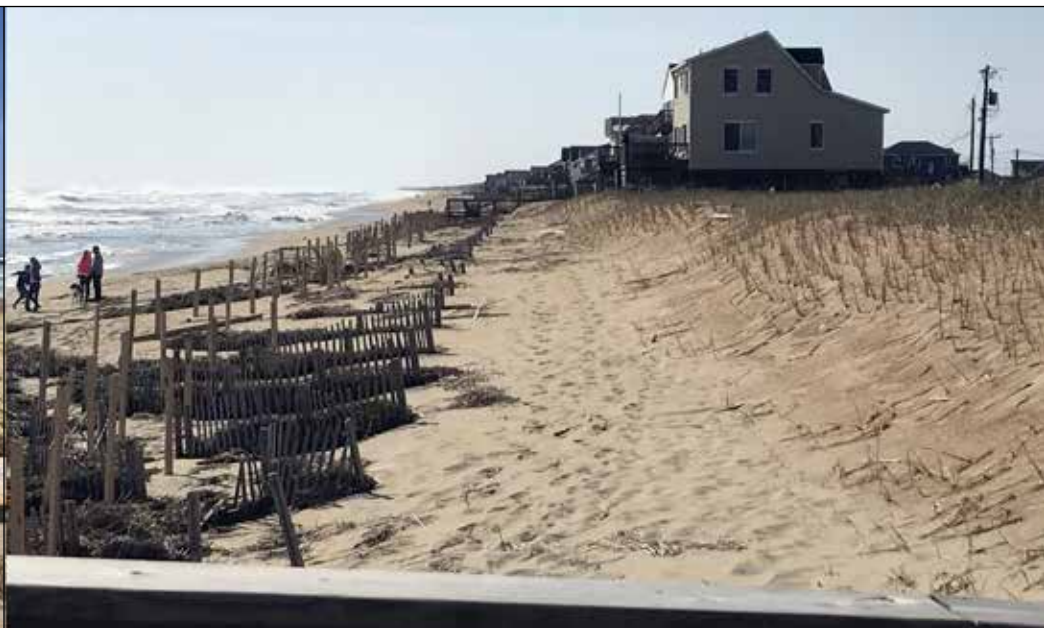
Traveling further south, the group stopped at the Hilton Garden Inn to view the edge effects of a dune project at the border of two towns (Figure 4). On one side, American beachgrass (*Amphiphila breviligulata*) had been planted to increase the stability of the sediment. Looking at the vegetated and unvegetated dunes in the two towns, two distinct environments could be observed in close proximity.

Figure 4 (below). Edge effect of dune planting at the border of two towns.

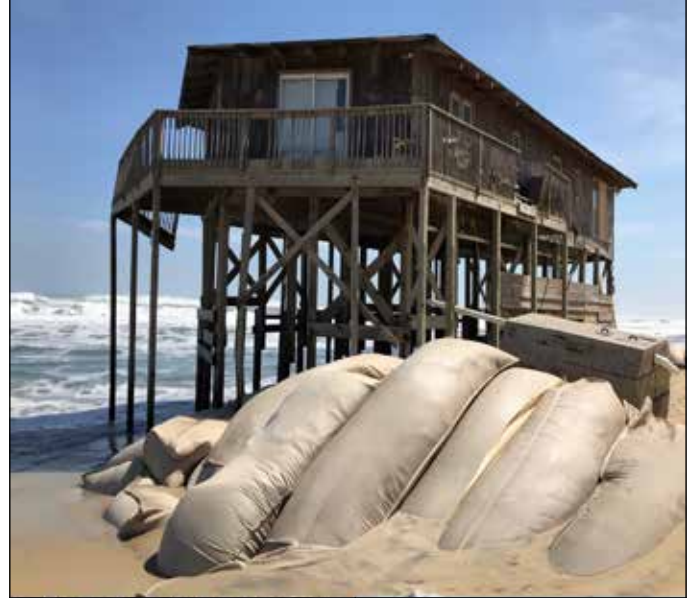
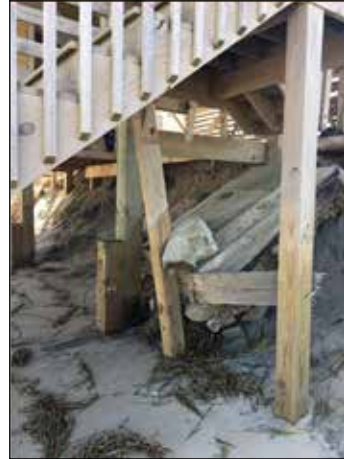
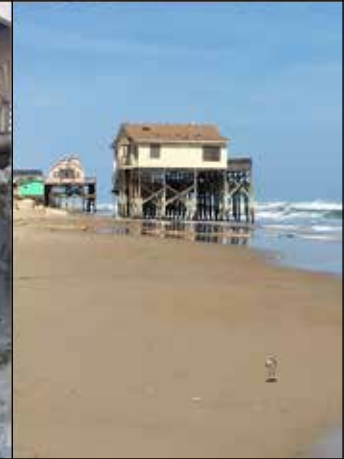
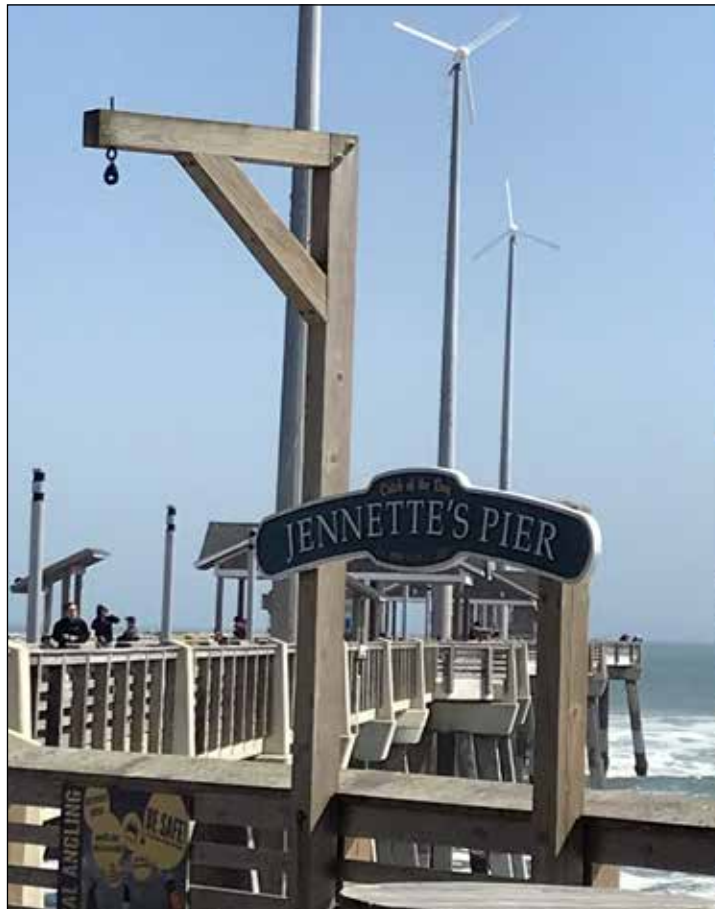
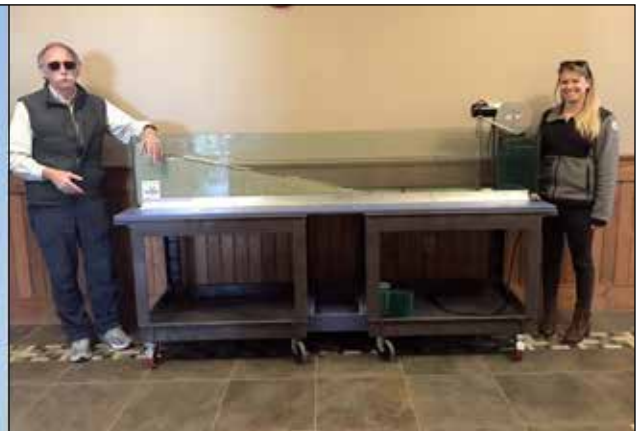
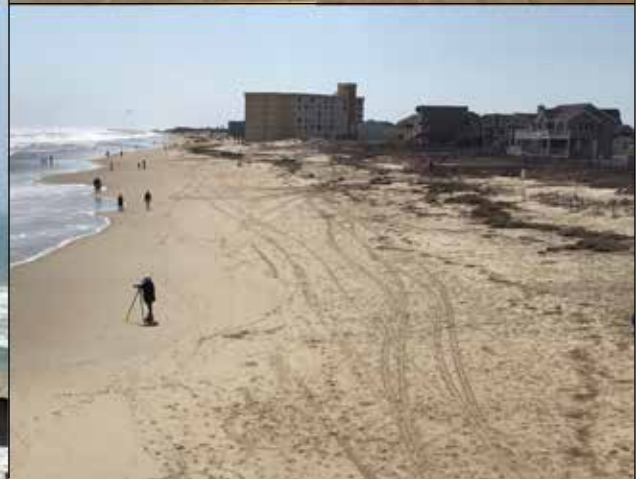
The group continued their travels south towards Rodanthe. The high erosion rates and lack of dunes in this area has resulted in major overwash and run-up of water under elevated buildings. One solution was to add to add a dune under the houses, however this resulted in a loss of parking; therefore, it was not an ideal trade-off for the homeowners who underappreciate the risks of safely maintaining homes here. Many houses were exposed to the elements so the infrastructure had to be creatively connected to electric wires

Figure 7 (right). Lack of dunes and high erosion caused overwash in Rodanthe and results in creative methods of securing septic systems and electrical connections.

and sewer pipes. The innovative solutions are just temporary fixes compared to Mother Nature's wrath (Figure 7). Other methods to stem erosion and prevent overwash were to build temporary piles of sand along the roadside to keep the sand off the streets and to place sand back onto the beach front (Figure 8).

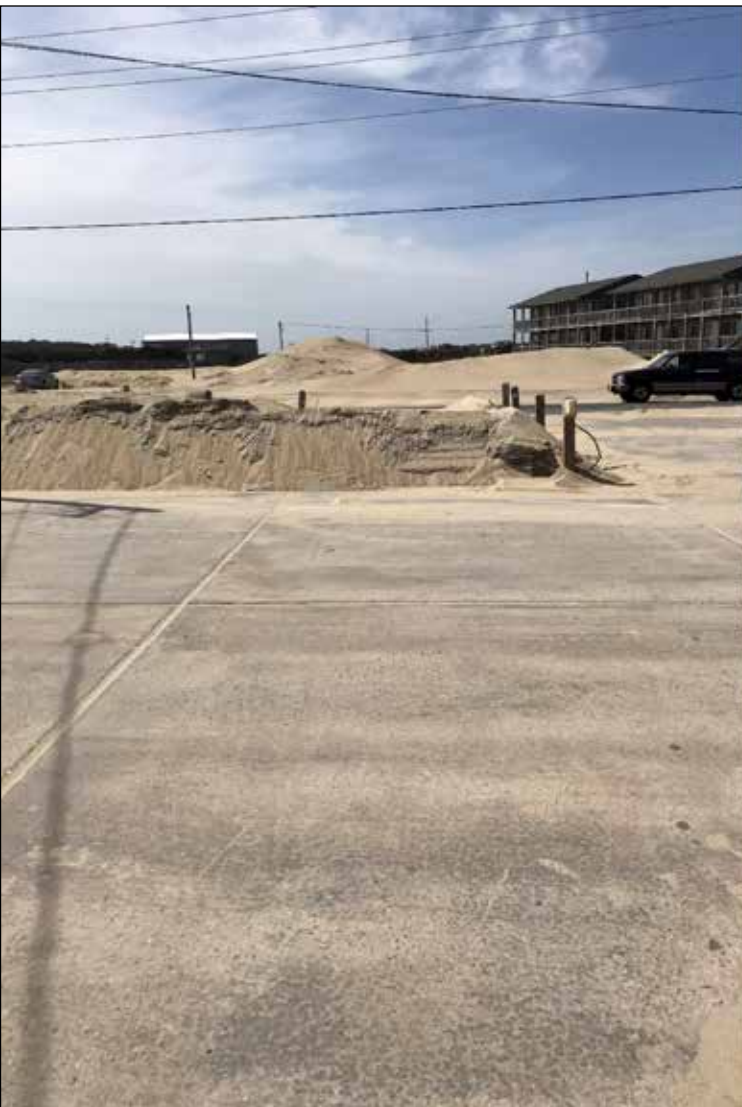
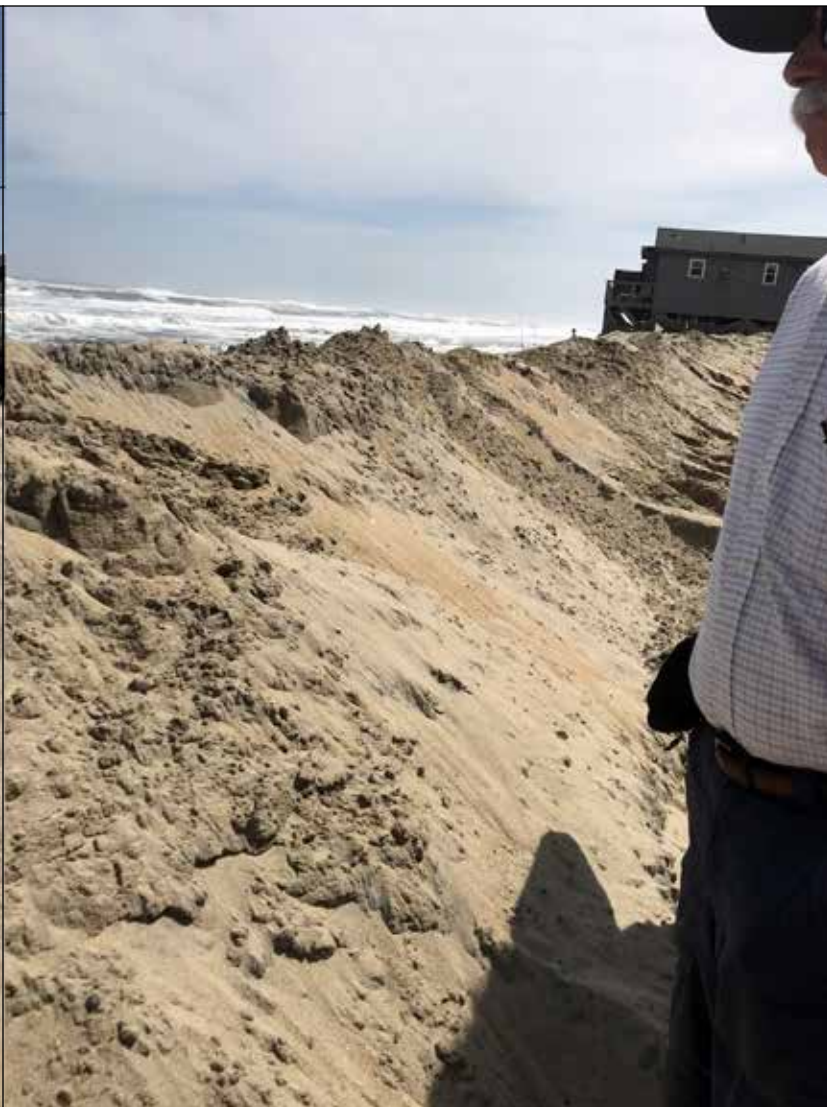
Figure 8. Temporary sand pile along the road to keep sand out of the streets (left). Temporary sand piles on the beach front to protect the houses from overwash (right).

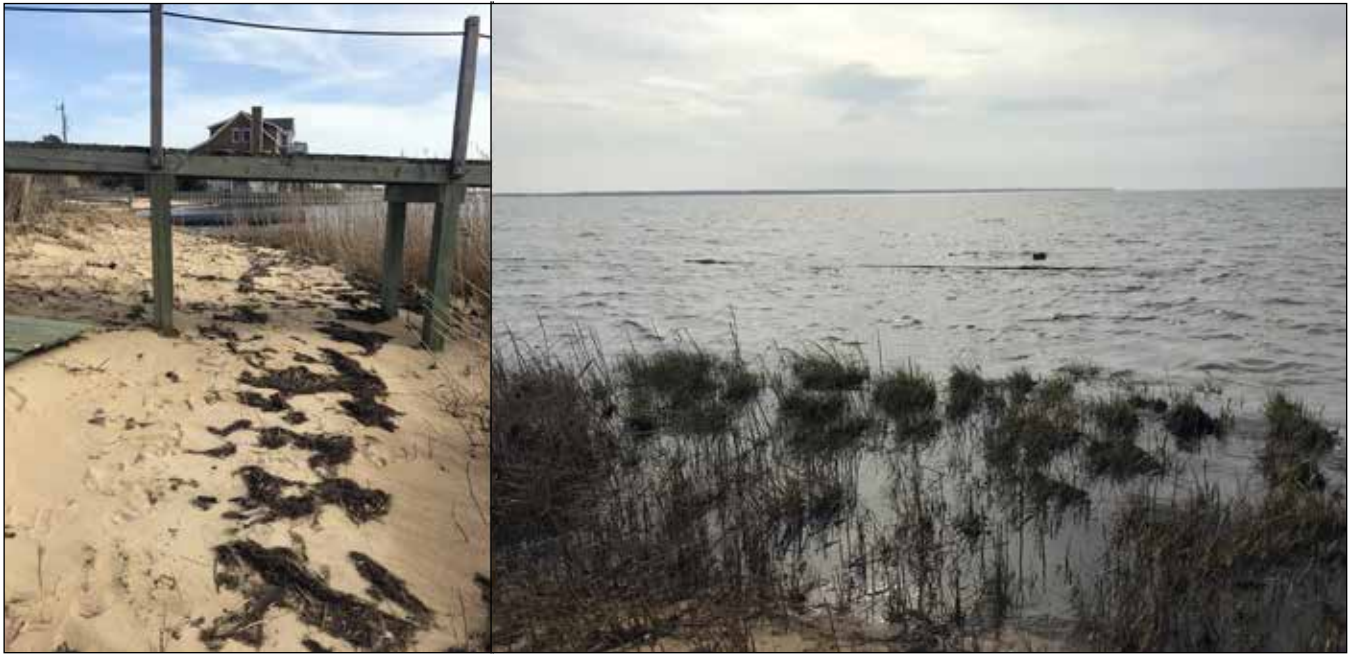
Figure 10. Long-standing living shoreline for erosion control and sediment accretion.

On the way back to the conference, one last stop was made just south of Jockey's Ridge State Park to view a long-standing living shoreline on a private property where a wooden sill with gaps was used to help accrete a sandy beach (Figure 10).
