**WATER QUALITY SAMPLING RESULTS FOR DILLON'S CREEK MARINA  
HULL WASH WASTEWATER TREATMENT SYSTEM EVALUATION**

***Site Location:***  
**Dillon's Creek Marina**  
**240 Lake Ave**  
**Island Heights, NJ 08732**

**Prepared By:**  
**NAJARIAN ASSOCIATES**  
**One Industrial Way West**  
**Eatontown, NJ 07724**

**April 2009**

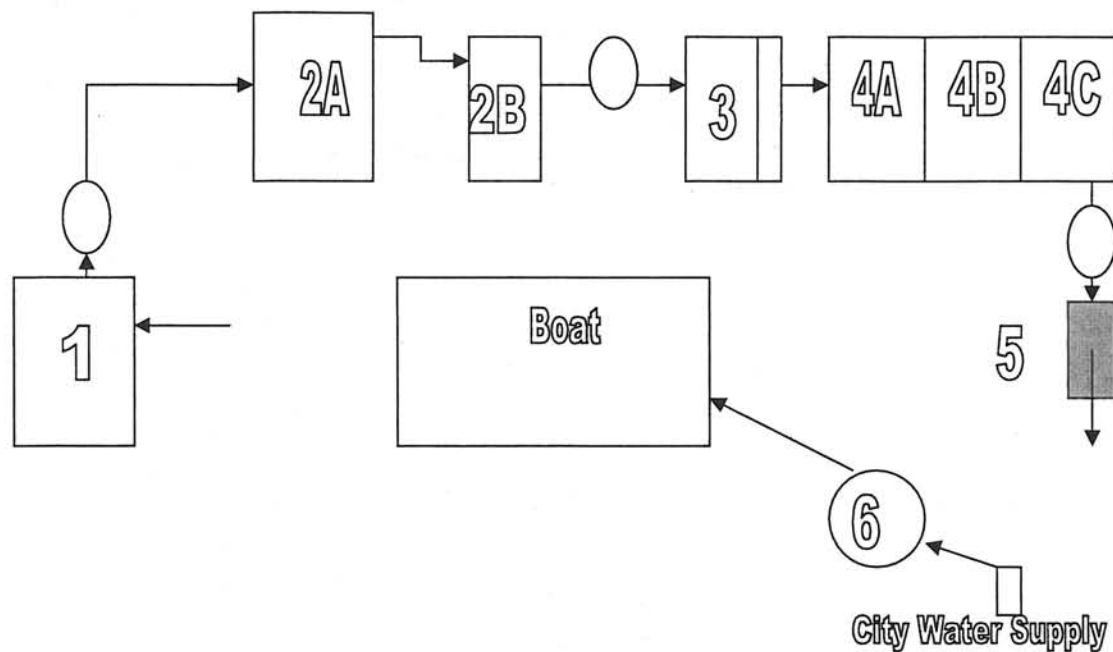
Figure 1. Water Maze Electro-Coagulation Treatment System Flow Diagram / Sampling Locations.

**COMPONENTS:**

- 1. SUMP
- 2A. U/S PRIMARY TANK
- 2B. D/S PRIMARY TANK
- 3. ELECTRO-COAGULATOR
- 4A – 4C SOLIDS SEPERATION / SECONDARY SETLLING TANKS
- 5. EFFLUENT FILTER
- 6. FRESH WATER SUPPLY

Based on the sampling results, it was recommended that the various components of the installed treatment system be upgraded and/or redesigned in order to achieve the target treatment goals. Water Maze further upgraded the installed treatment system in 2008 through the incorporation of automatic solid purging system and various adjustments within the treatment train. Also, a larger, multi-chamber water quality sump was installed at the Marina to enhance the overall treatment efficiency. During the 2008 boat wash season, additional five rounds of samples were collected from various locations along the treatment train for laboratory analysis.
