Vessel Wash Wastewater Treatment System Profile

Roseman's Boat Yard

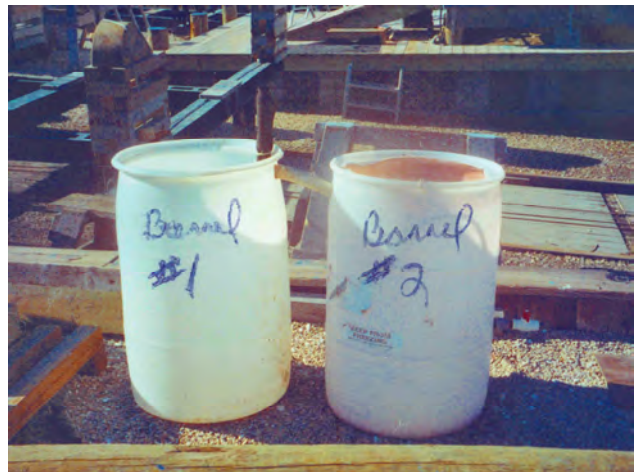
Roseman's two-barrel system facilitates the process of settling solids in wash waste water.

The water passes over a piece of filter fabric, which helps remove any large solids that may have been pumped off of the tarp. Organic matter and paint chips are allowed to settle in the first barrel. When the first barrel is full, water, via a connecting hose, begins to transfer to the second barrel.

An automatic sump pump located in the second barrel is activated when it is approximately three-quarters full. The water is then pumped into the sanitary sewer line. Barrel number one is allowed to settle for

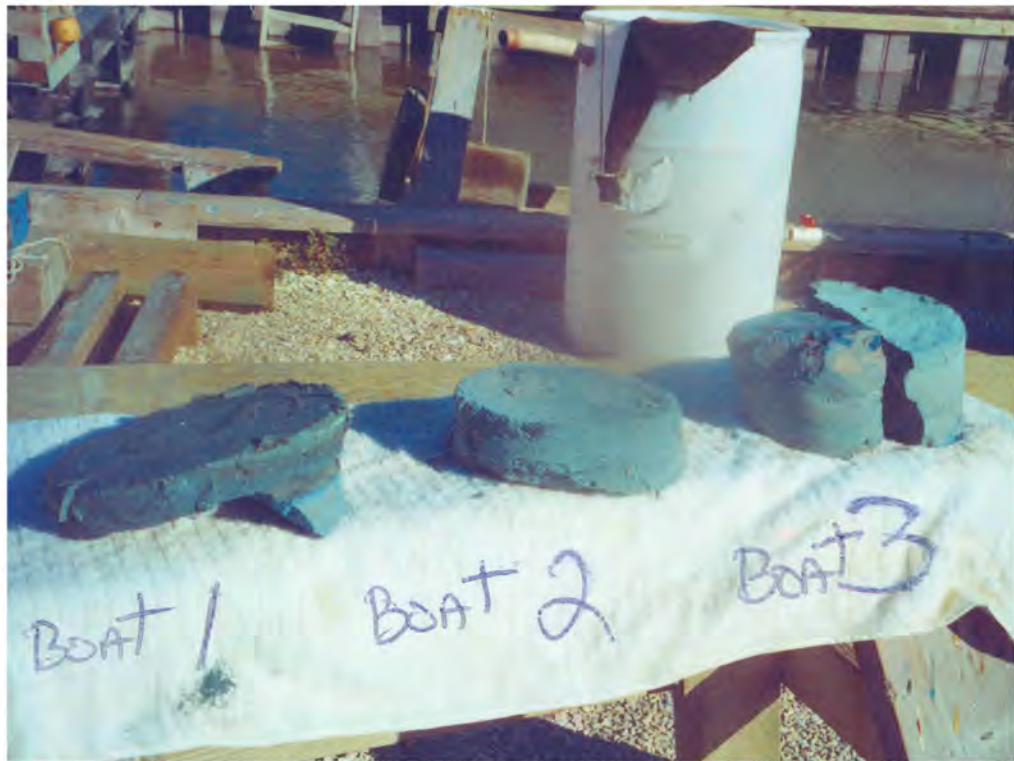
After approximately two weeks, the water evaporates completely and any undissolved solids (paint chips and other organic matter) are left behind.

approximately 24 hours and is then pumped down until approximately five gallons remain. The remaining wastewater is poured into a five-gallon bucket and set aside to evaporate. It takes approximately two weeks for the water to evaporate, and a cake consisting of paint chips and organic matter remains in the bucket after evaporation. This cake is then bagged and placed in the garbage.
